Miccosukee Greenway Flooding Evaluation – Final Report

Leon County Public Works Department

December 8, 2025

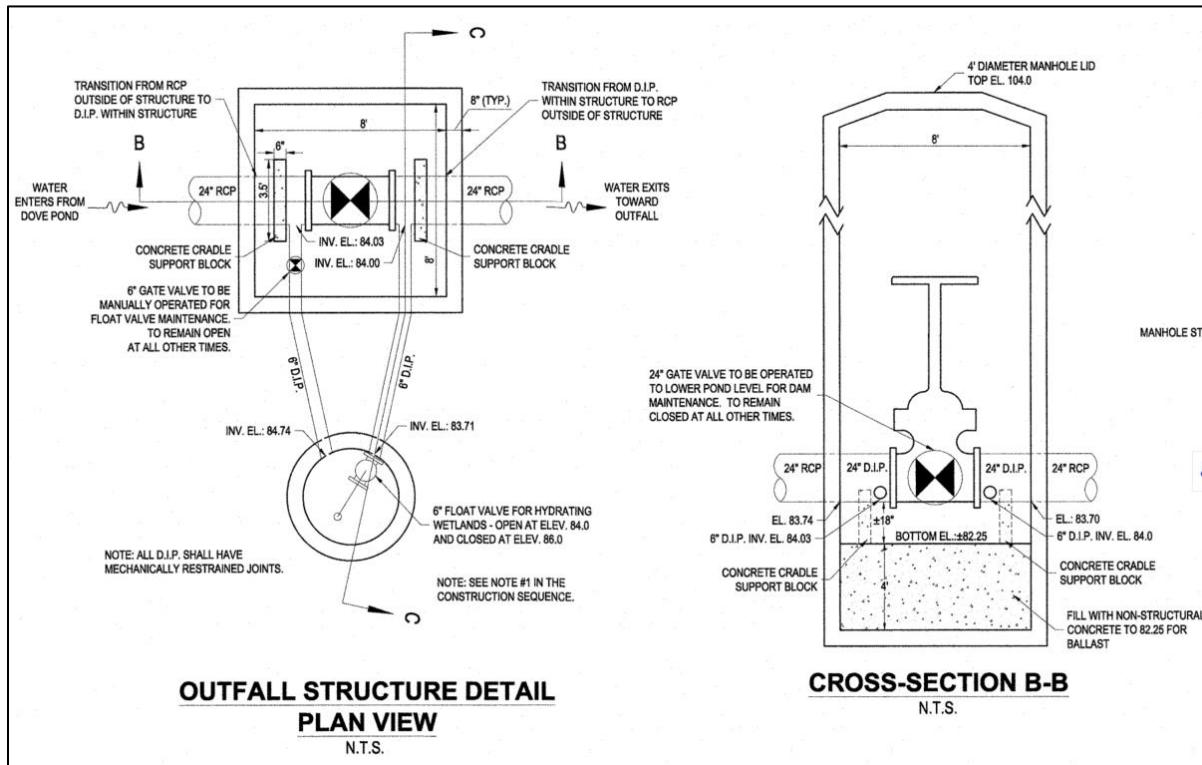
Figure 5: Schematic of Discharge Pipe and Valves through Dove Pond Dam

- a. 24" gate valve located in the 24" RCP – intended to drain Dove Pond when needed for maintenance.
- b. 6" float valve built to keep the downstream wetlands hydrated.
- c. 6" gate valve in the 6" DIP – built to be able to maintain the float valve.

Confirm the functionality and status of the structures through the dam:

- a. 24" gate valve located in the 24" RCP
- b. 6" float valve is operating at appropriate elevations
- c. 6" gate valve in the 6" DIP

Inspection of the gate valves and floats on the pipe through the dam should be a simple, no-cost request by Leon County to the Dove Pond Community Development District (maintaining agency for the dam). If inspection of the gate and float valves determines that a valve is stuck open or leaking, repairs should be pursued, and the performance of the area should be monitored to determine if further action is necessary.

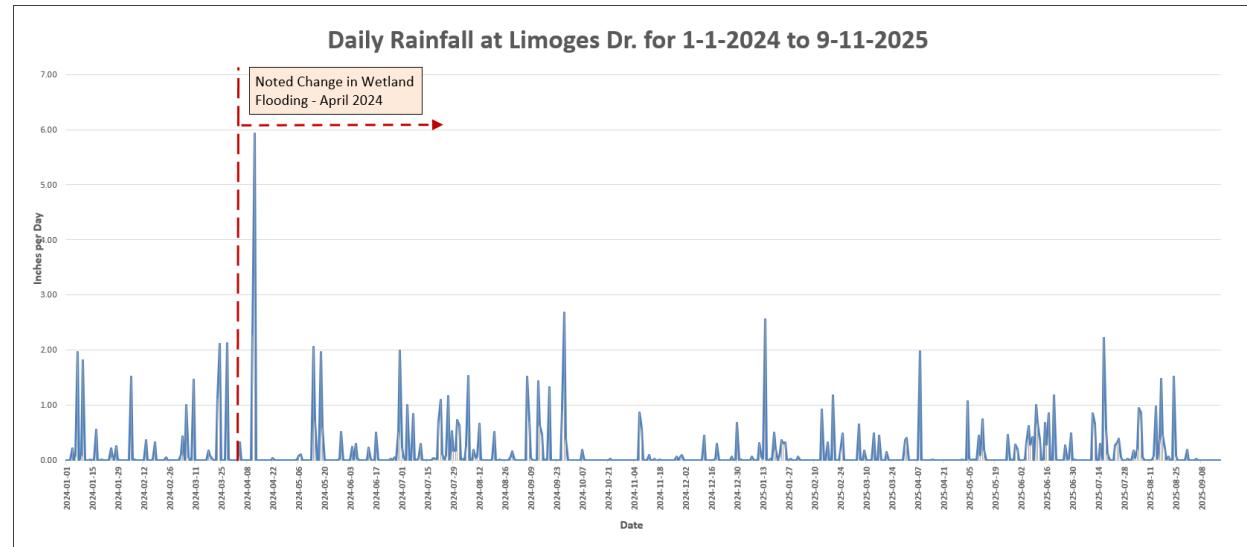
Figure 10: Daily Rainfall at Limoges Dr. from 1-1-24 to 9-11-25 (Source: [NWFWM Hydrologic Data WebPortal](#).)

As can be noted from **Figure 10**, below, no significant rainfall events have occurred, during the timeframe when flooding was observed in the Greenway Wetland, other than the 2-day event on April 11 - 12, 2024.

The measured rainfall from April 11 – 12 totaled 8.19" and, if one assumes that that rainfall occurred within a 24-hour period, the measured April 11 – 12 rainfall interpolates to an 18-year rainfall event, using [NOAA Atlas 14 Florida rainfall frequencies](#) for the Limoges Dr. Station.

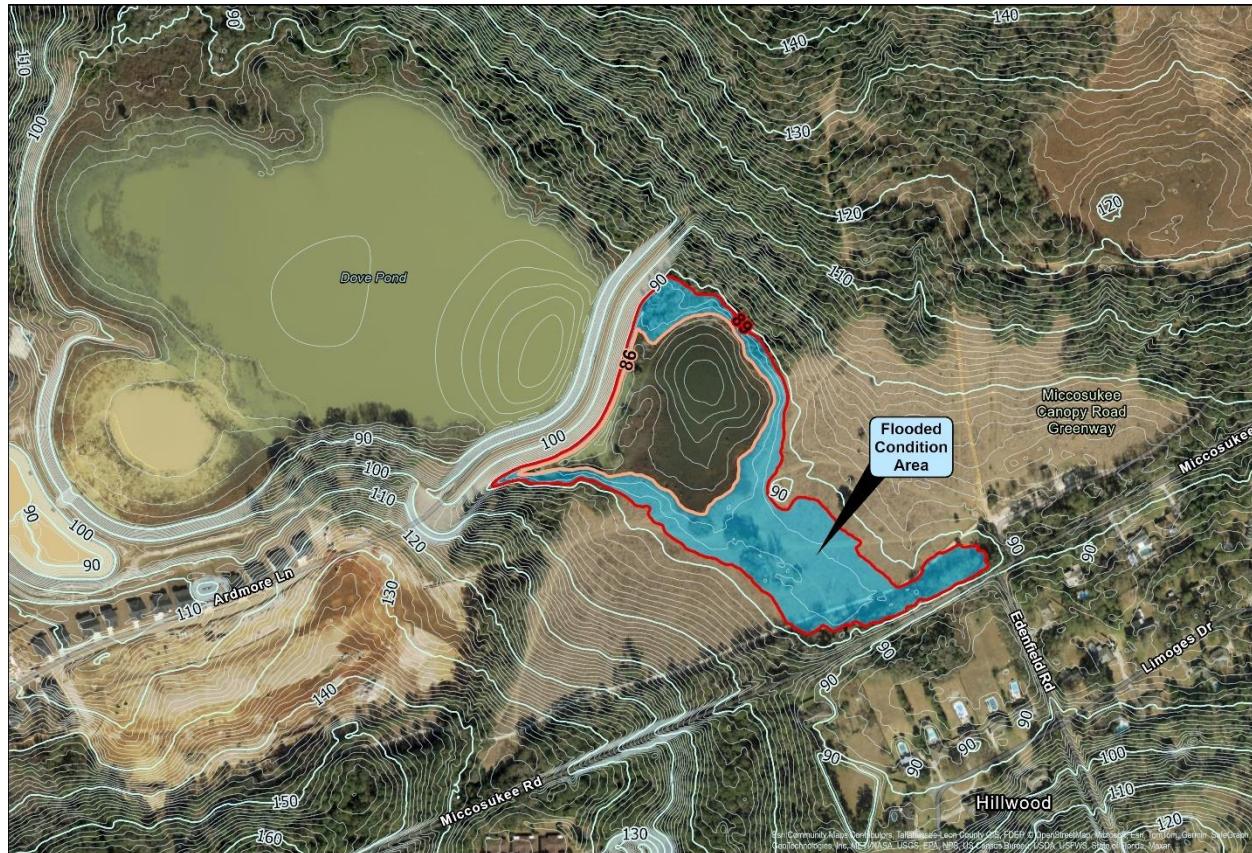
Figure 11: Delineation of Flooded Conditions at the Greenway Wetland (Contours in ft-NAVD)

From **Figure 11**, below, and for purposes of this report, a “flooded condition” is defined as flooding between elevation 86-89 ft-NAVD, which is when trail use is restricted. Flooding at elevation 86 ft-NAVD restricts use of the northern trail adjacent to the Greenway Wetland, and at elevation 89 ft-NAVD, the Greenway trail southwest of the Edenfield parking lot is impacted.

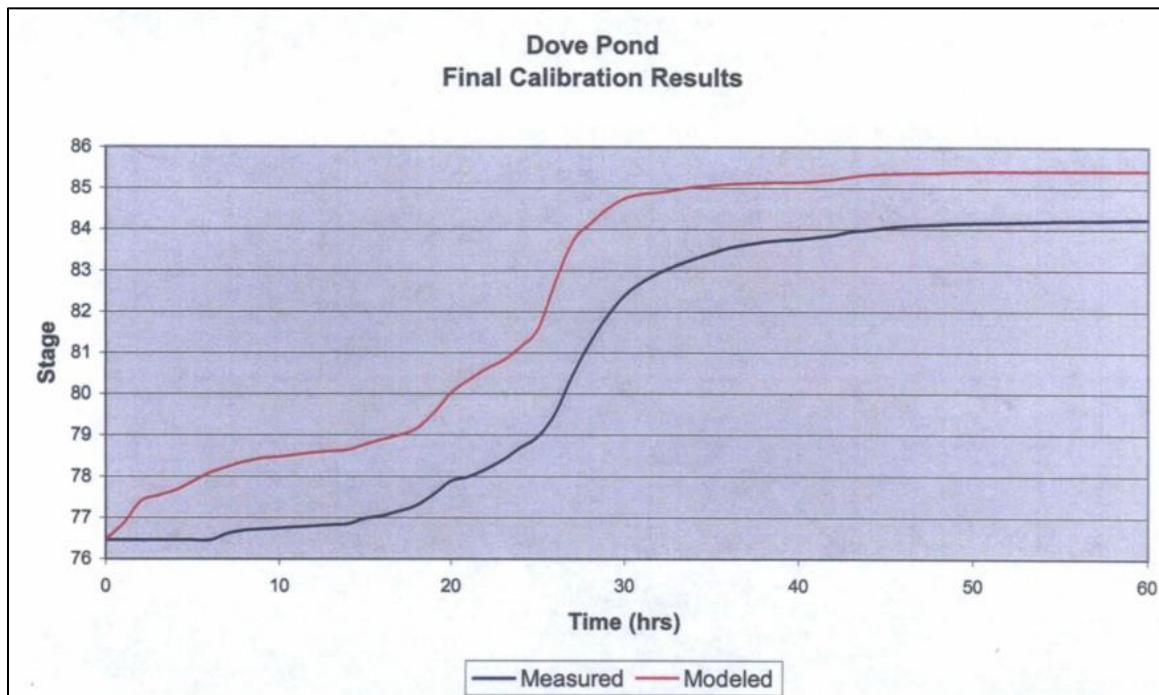
Figure 17: Stage Results of Final Calibration of the Predevelopment SFMP model (SFMP, Volume 2)

This robust SMFP calibration effort focused on matching total runoff volumes for Tropical Storm Fay but could be overly conservative with regards to stages from lesser storm event durations. The graph in **Figure 17**, above, indicates modeled stages in Dove Pond are approximately 1.5-2.5 ft higher than measured results, which would cause the model to over-predict flooded conditions at the Greenway. Thus, increased pre-development model stages, beyond those normally observed at the Greenway, could be a result of the volume-focused calibration efforts.

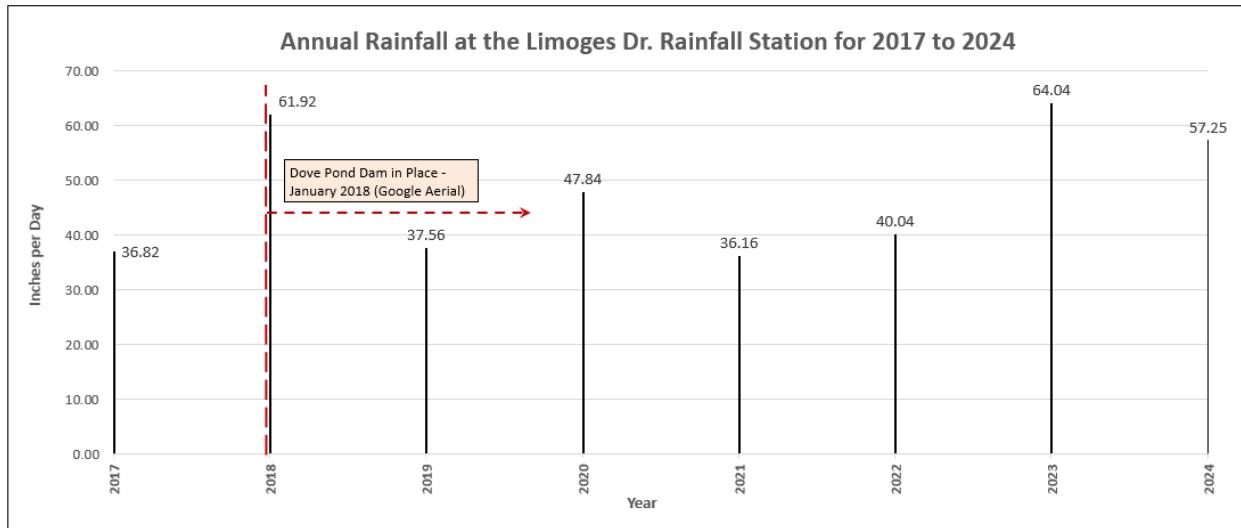
Figure 23: Annual Rainfall at Limoges Dr. from 2017 – 2024 ([Data - NWFWM Hydrologic Data WebPortal](#))

Figure 47 shows Dove Pond Dam functionally constructed by January 2018, but flooding was not reported until April of 2024. This could be attributable to below average annual rainfall in Leon County in the years after dam construction in January 2018 as shown in **Figure 23**, below:

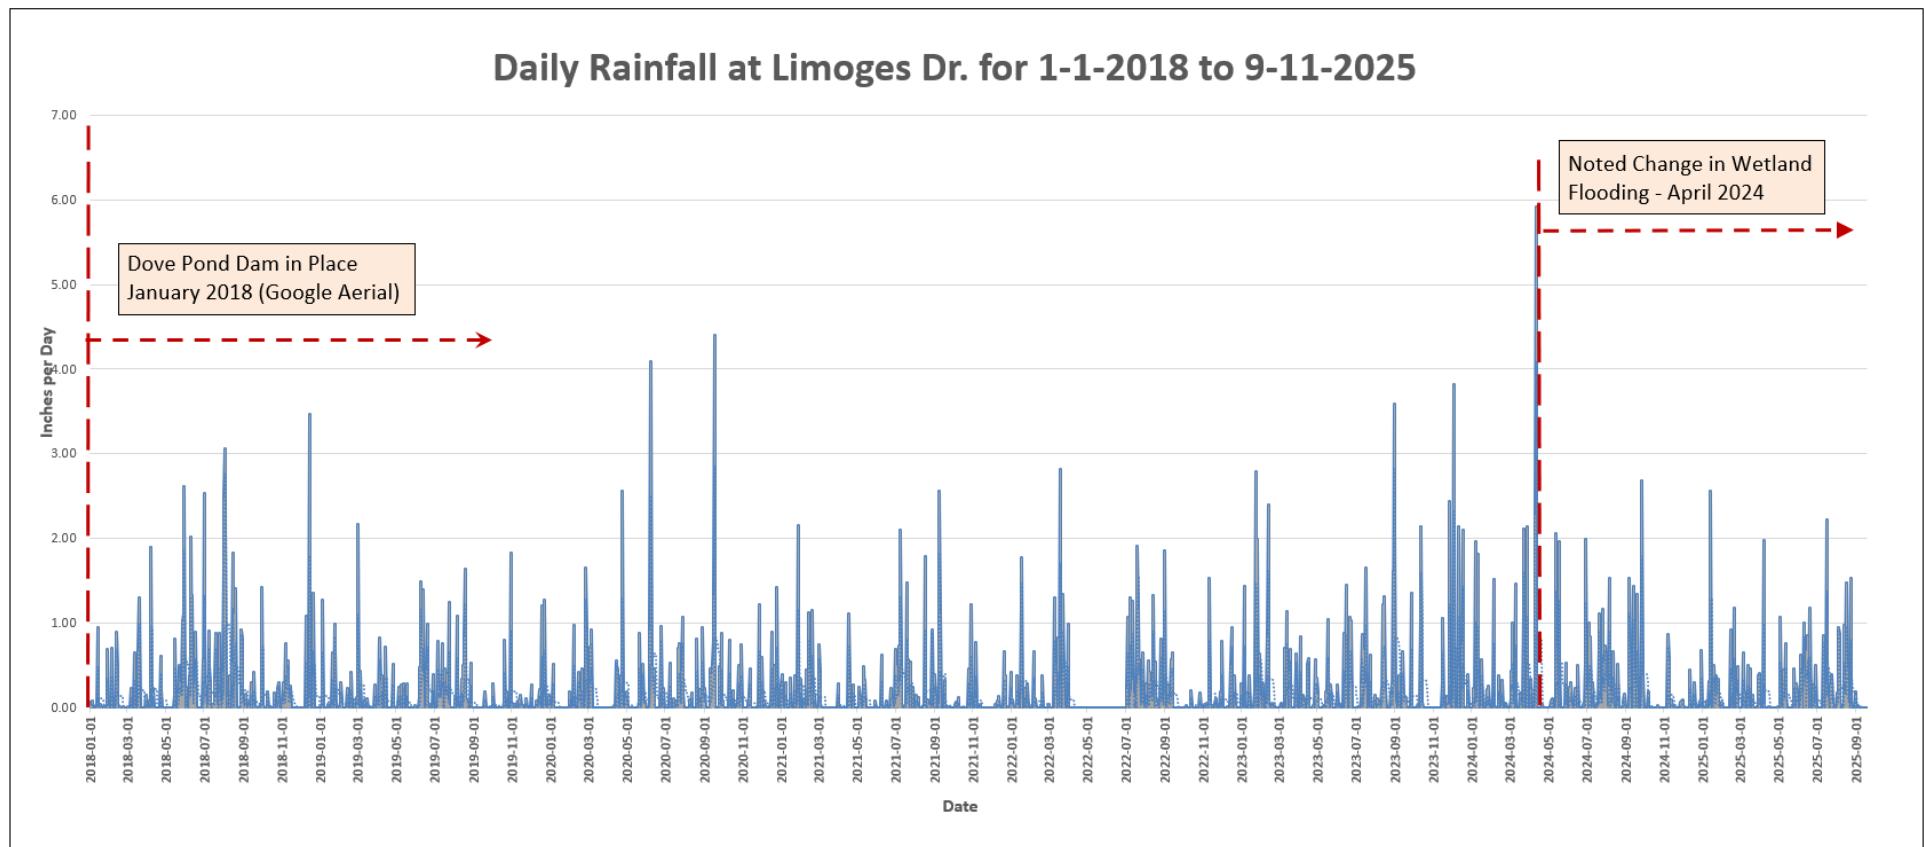
Figure 24: Daily Rainfall at Limoges from 1-1-2018 to 9-11-2025 ([Data - NWFWM Hydrologic Data WebPortal](#))

Figure 24, below, is a graph of daily rainfall totals for Limoges Dr. from 1-1-2018 to 9-11-2025, showing a lack of heavy rainfall events in the period after construction to present day; **Figure 25**, further below, shows the same data summarized monthly.

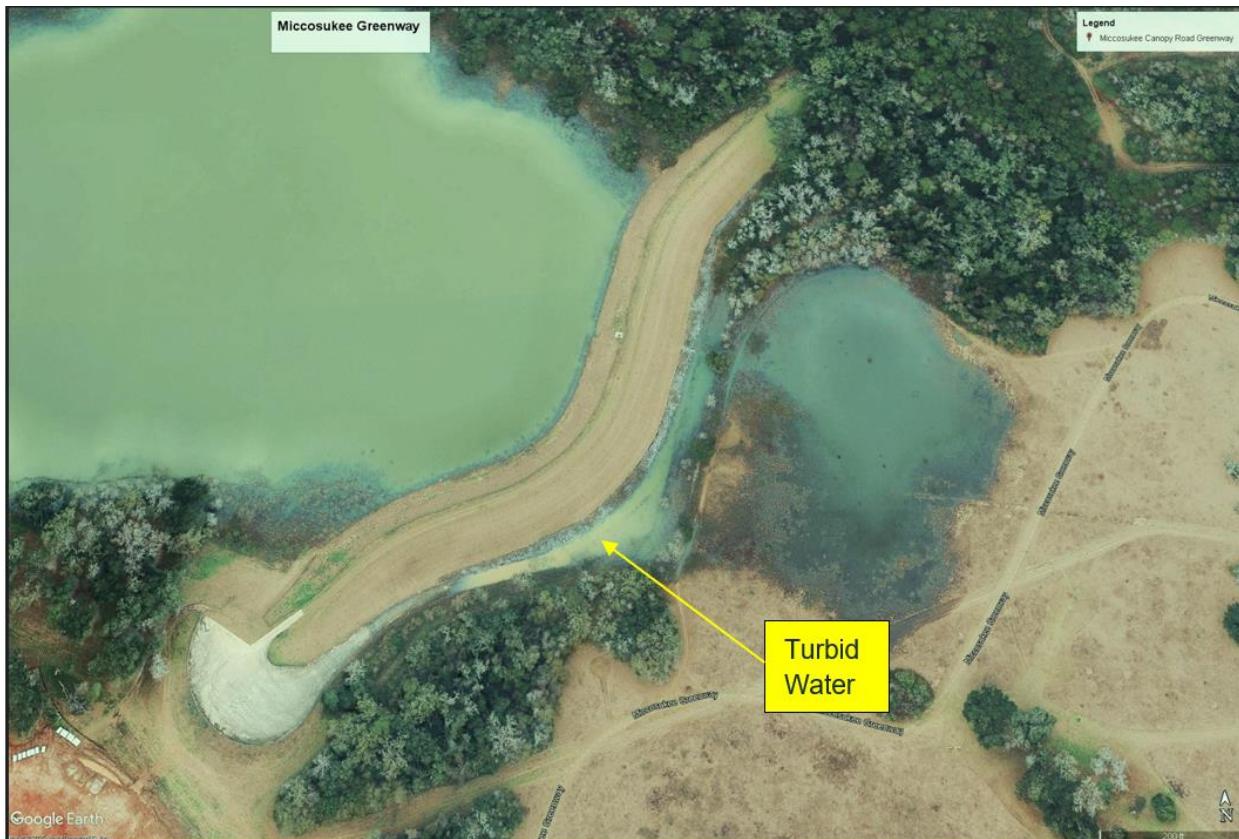
Figure 26: Close up of Figure 50: Google Earth Aerial – January 2024, with Picture Properties Adjusted

Figure 26, below, shows what appears to be turbid water immediately downstream of the dam:

The above observation of turbid water adjacent to the Dove Pond Dam could be evidence of active seepage at the dam.

While the field infiltration data submitted by Moore Bass as part of the City of Tallahassee Permit Modification was “insufficient justification” to meet permitting thresholds, initial field data suggests that infiltration field measurements do differ from design values and merit further investigation. Higher infiltration rates within Dove Pond could be attributable to seepage through one (or more) of the valve structures or the dam itself.

- ii. If the gate and float valves appear to be constructed and functioning properly, engage a Geotechnical Engineer to investigate if additional seepage is occurring at the dam. Possible testing includes the following:

- 1. Dye test
 - 2. Ground penetrating radar
 - 3. Piezometers for infiltration/groundwater
 - 4. Turbidity measurements
- iii. References:
 - 1. [Seepage Surveillance & Monitoring - ASDSO Dam Safety Toolbox](#)

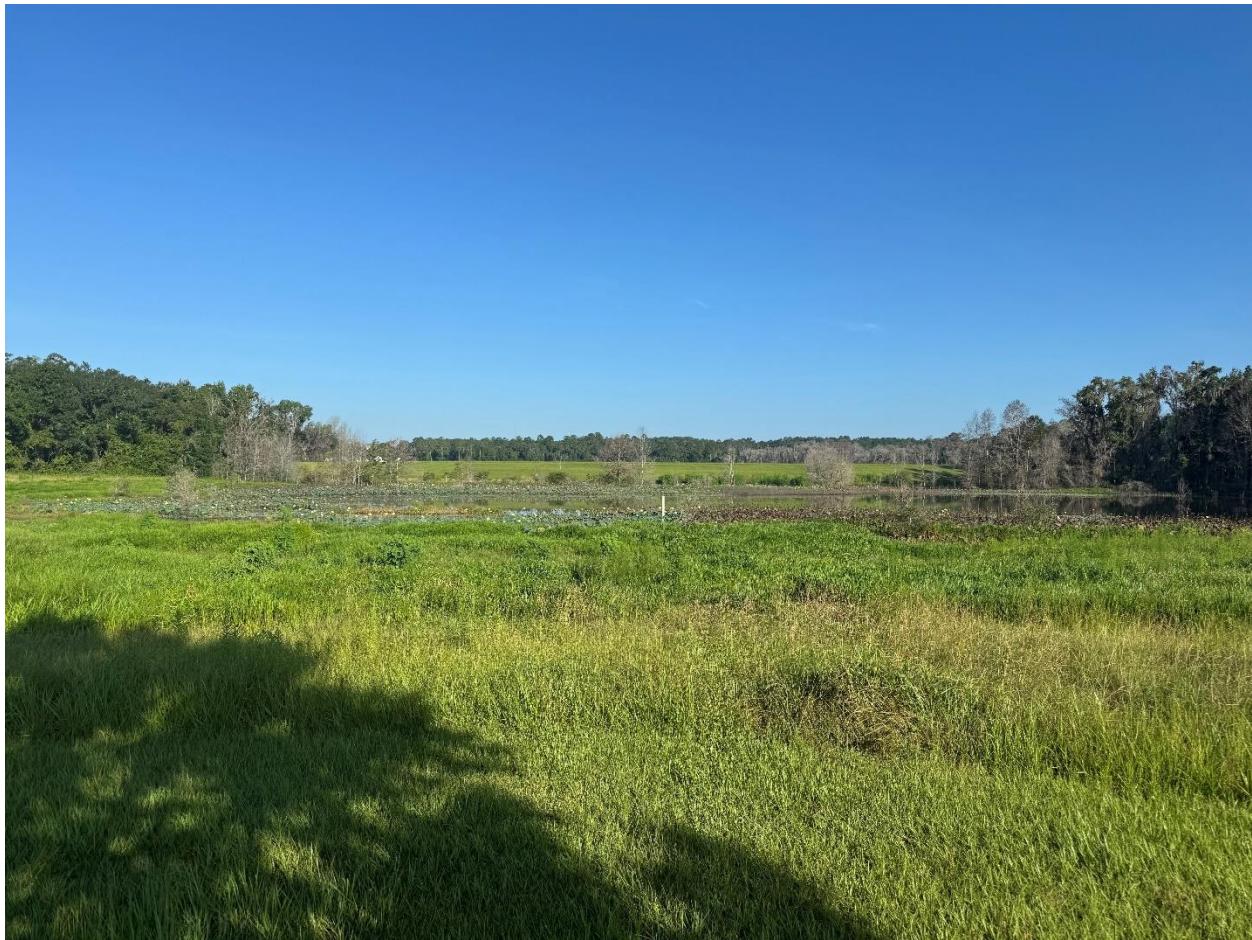
Photograph 5: Wetland Immediately Downstream, of Dove Pond Dam

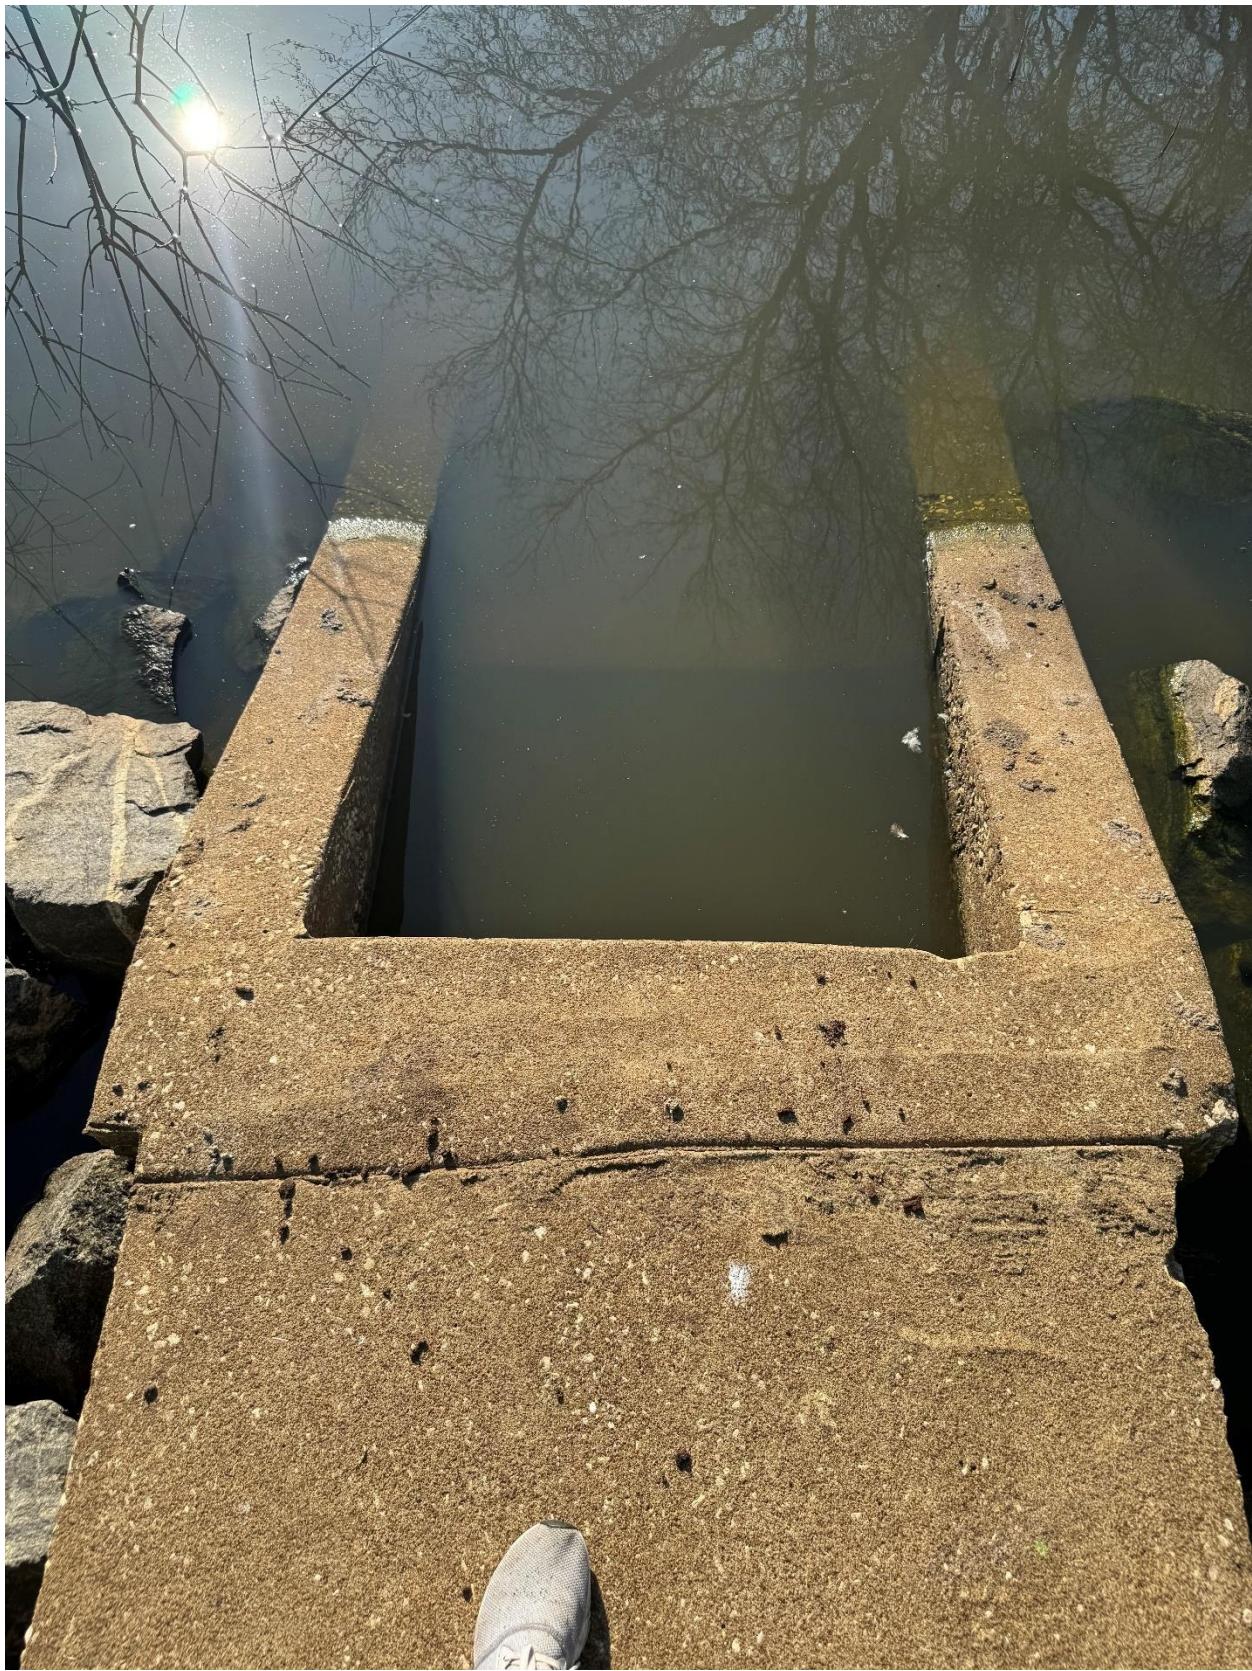
Photograph 8: Downstream Outlet of Discharge Pipe through Dove Pond Dam
