Miccosukee Greenway Flooding Evaluation – Final Report

Leon County Public Works Department

December 8, 2025

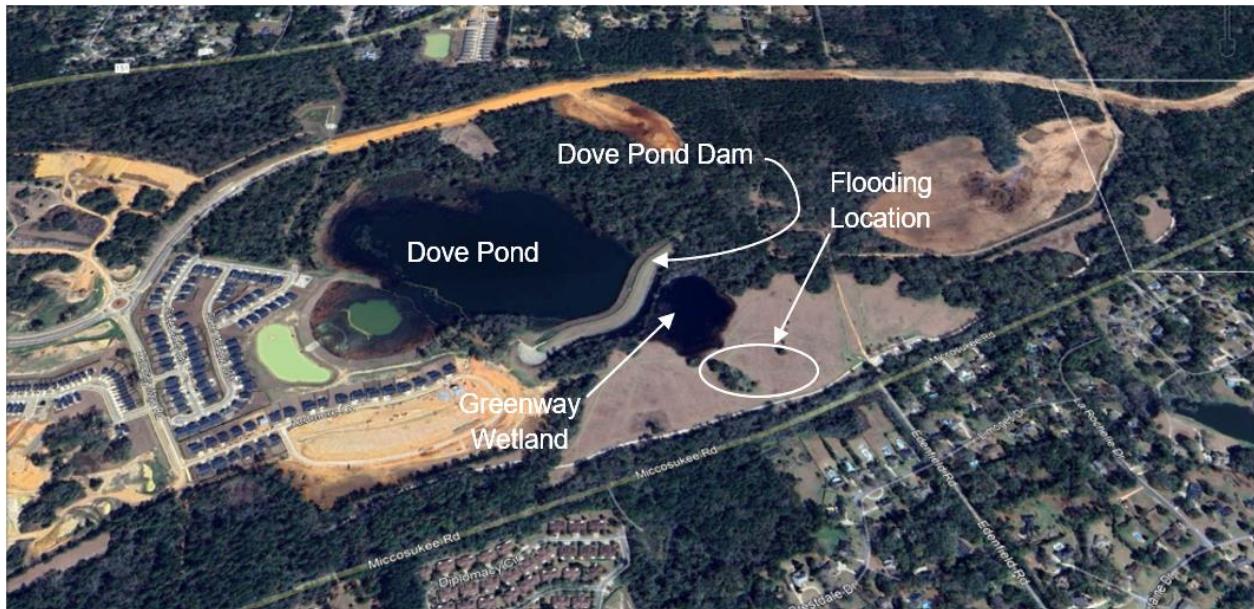
Figure 4: Area of Greenway Flooding Concern Being Studied in this Report

In researching the cause of the flooding identified in **Figure 4** above, AtkinsRéalis examined the documentation described in this section of this report and discussed findings with Leon County on August 13, 2025. That meeting is documented in the *Task 1 – Data Collection Memo* sent to Ms. Anna Padilla, Leon County Public Works Department, and included as **Appendix A** of this report. Key findings from relevant data sources are discussed below.

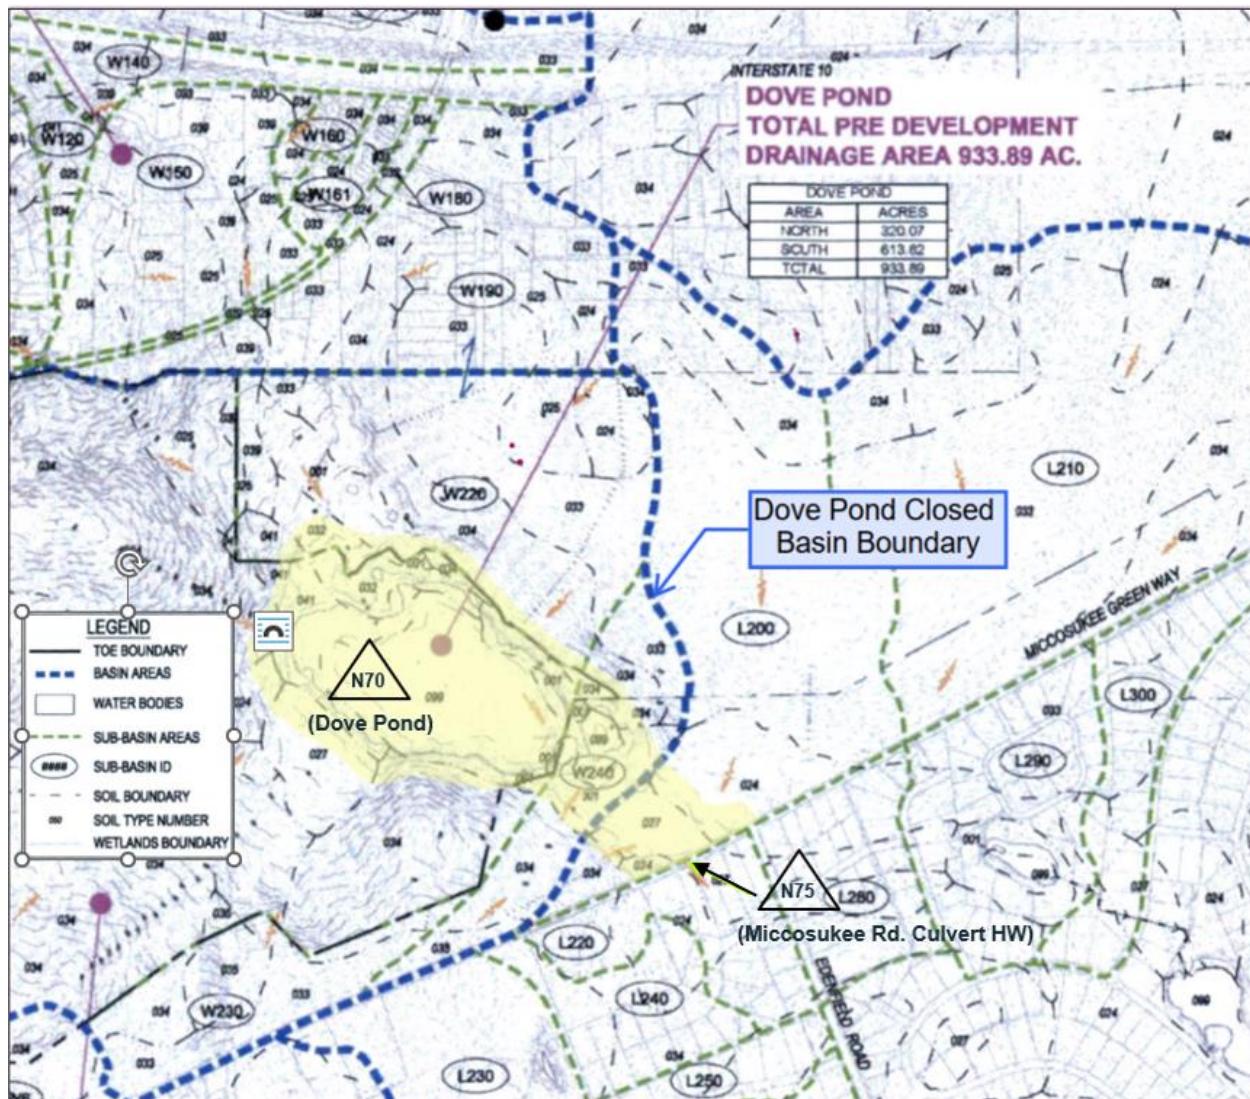
Figure 12: Graphic of Storage in Predevelopment Dove Pond - Node N70 (SFMP, Volume 3, with additional labels)

In the predevelopment condition, the storage associated with Dove Pond and the Greenway Wetland is modeled as one storage node (N70) with 933.89 contributing acres from Dove Pond North and Dove Pond South. In the existing conditions before construction of the dam, there was an overland connection between Dove Pond and the Greenway Wetland at around elevation 84 ft. The construction of the Dove Pond Dam severed the connection between Dove Pond and the Greenway Wetland, however it is unclear how the two areas communicated during lesser duration storm events before the dam was constructed. Flow behavior between the two storage areas cannot be directly determined from the pre-development model because the entire area was modeled as one storage node, shown in **Figure 12**.

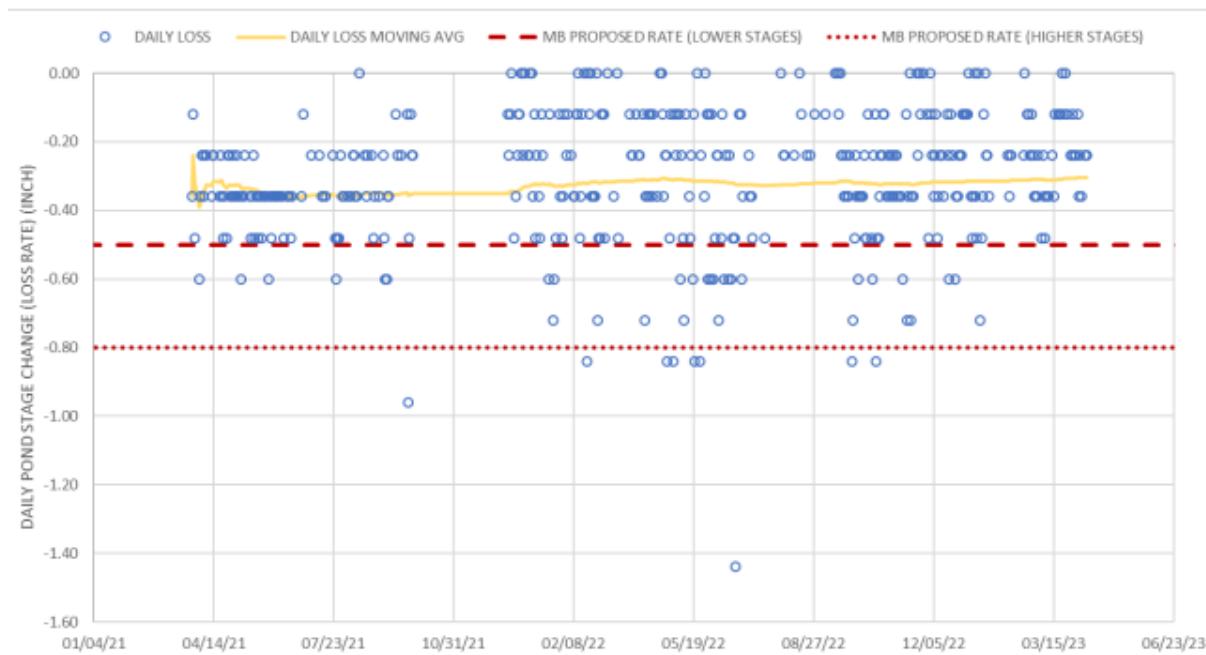
a. SWM's review of the provided data indicates observed total loss rates are more in line with approximately 0.3 inch/day. A comparison of daily loss rate observed at Dove Pond versus proposed basin infiltration rates is shown below. It should be noted, the observed total loss rate includes infiltration (vertical percolation as well as horizontal percolation) and evapotranspiration (ET) as shown in the equation below. The modeled basin infiltration rate should only consider percolation since ET is included in XP's hydrologic routine by default.

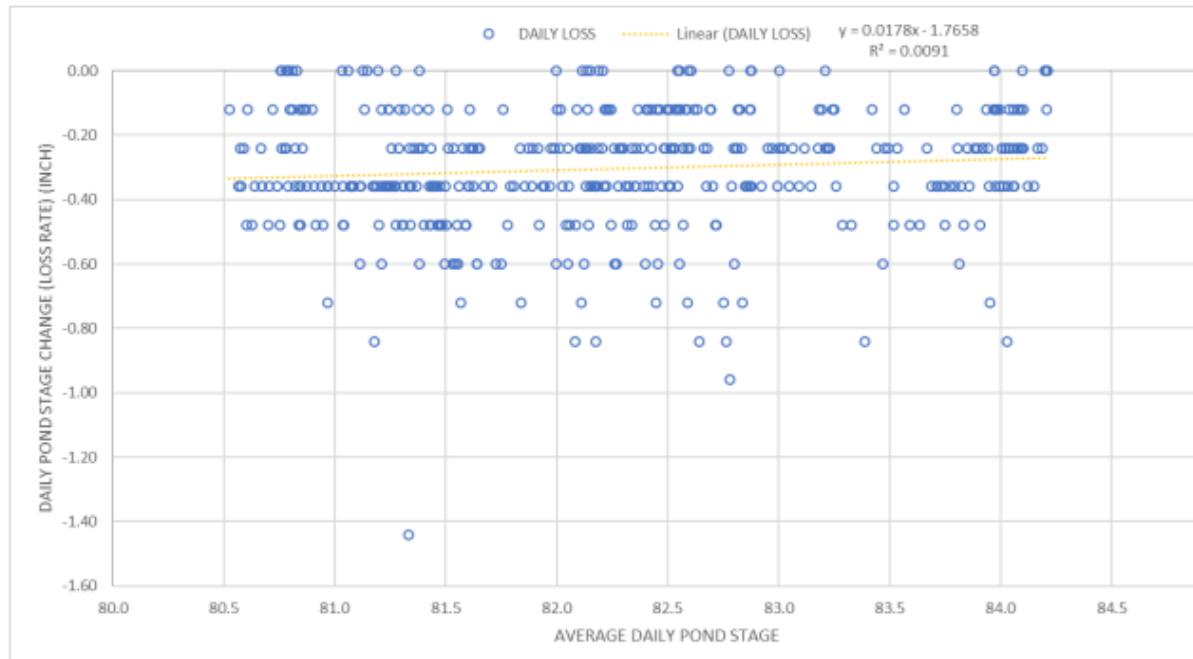
b. SWM's review also indicates that increasing infiltration rate with stage may not be justified based on the provided data. The observed loss rate exhibits a slightly decreasing trend with stage increase as shown below, where positive trend line slope indicates decrease in rate. However, it is noted that the observed stage range is relatively narrow and does not capture pond stages above 84.5' NAVD and the year 2021 was overall drier than the subsequent years monitored. More data is required especially at higher stages to better understand the relationship between pond stage and infiltration rate.

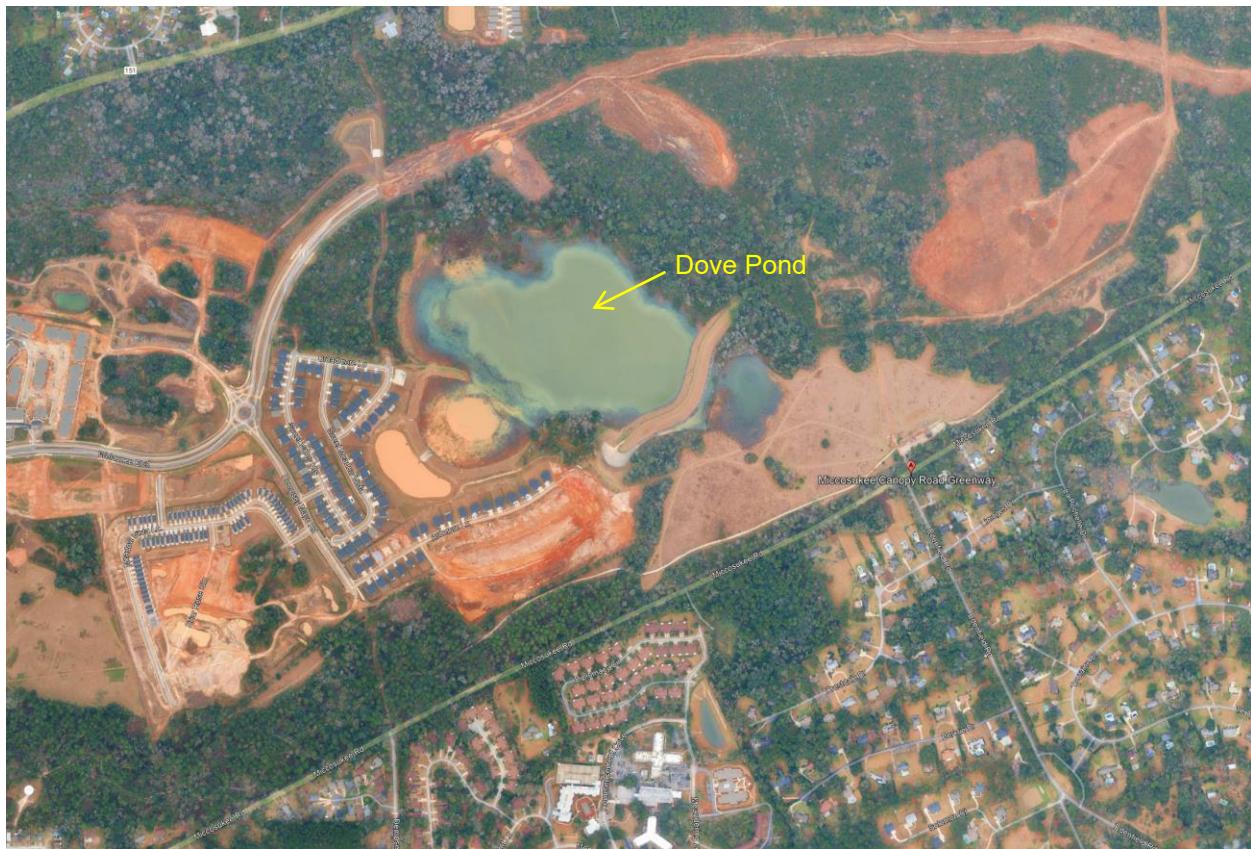
Figure 50: Google Earth Aerial – January 2024

Figure 26: Close up of Figure 50: Google Earth Aerial – January 2024, with Picture Properties Adjusted

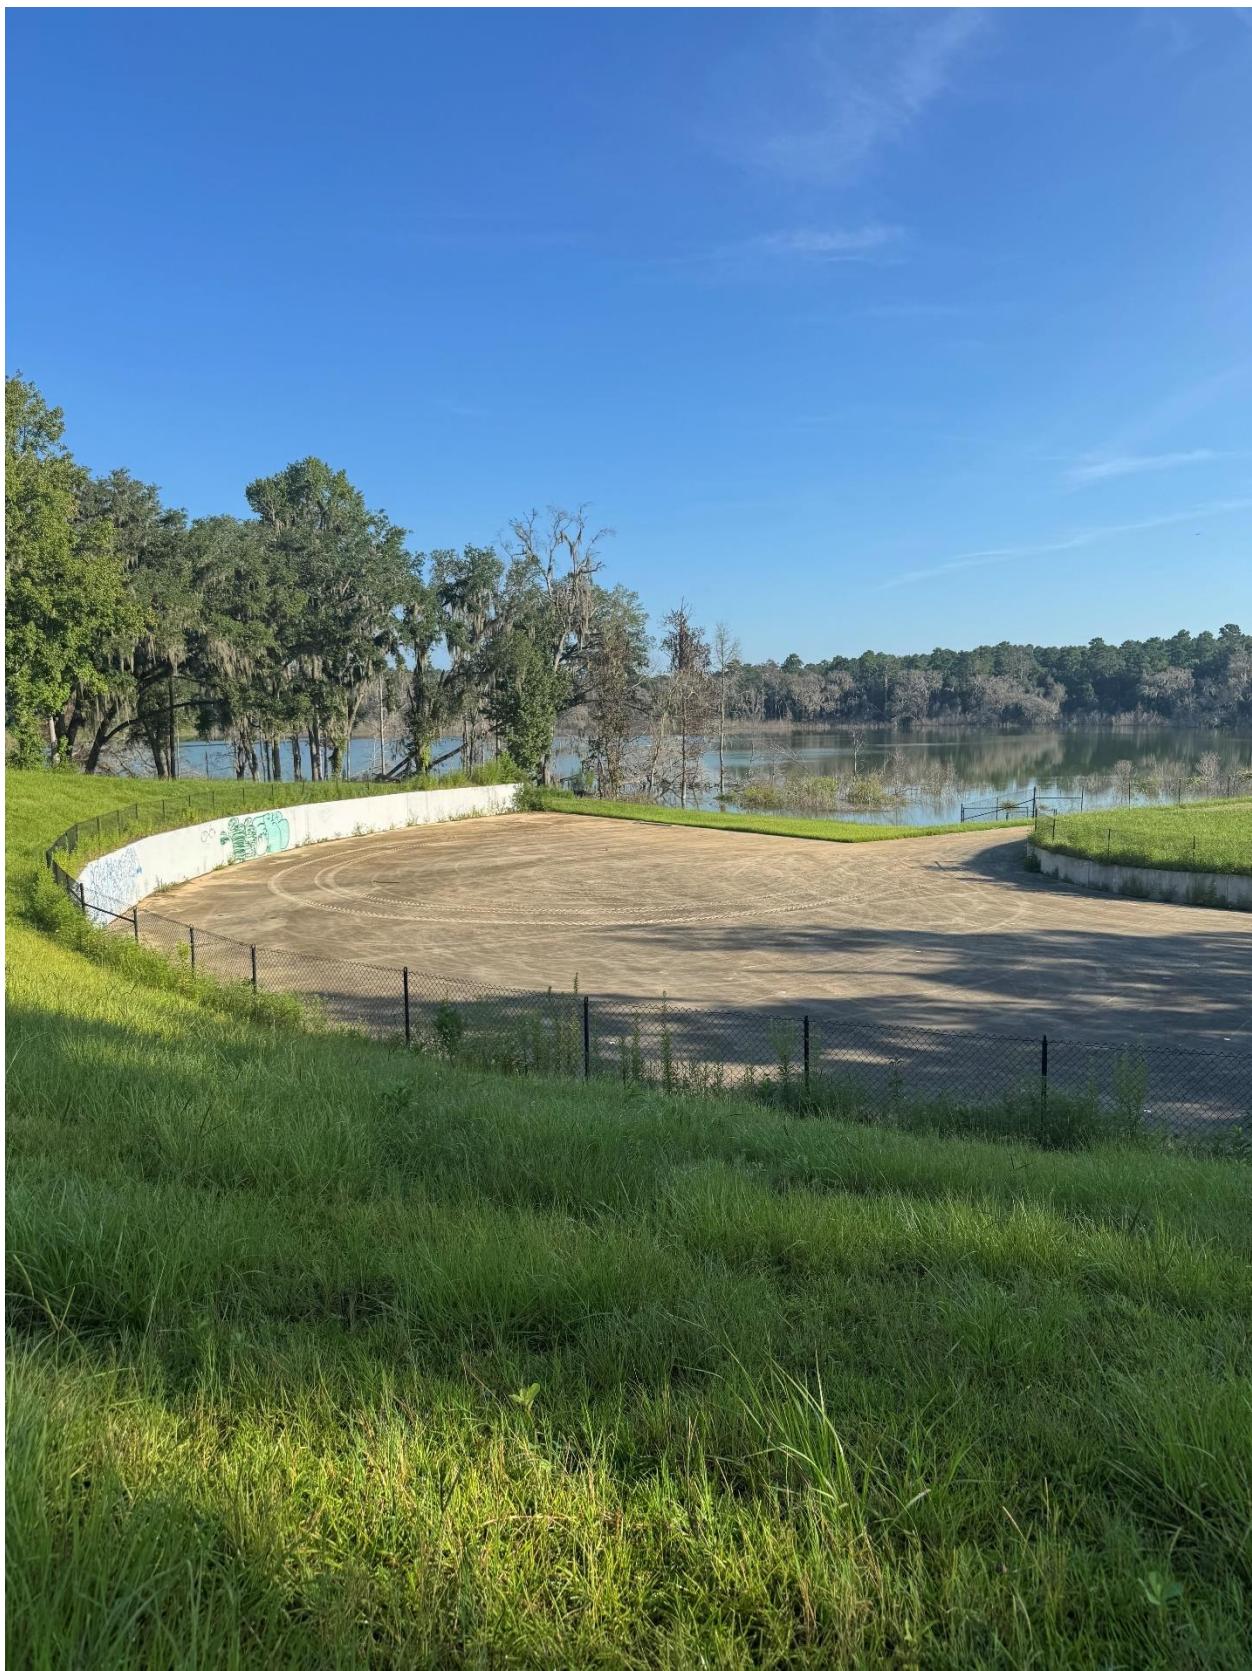
Photograph 2: Dove Dam Overflow Spillway, Looking from the Top of the Dam

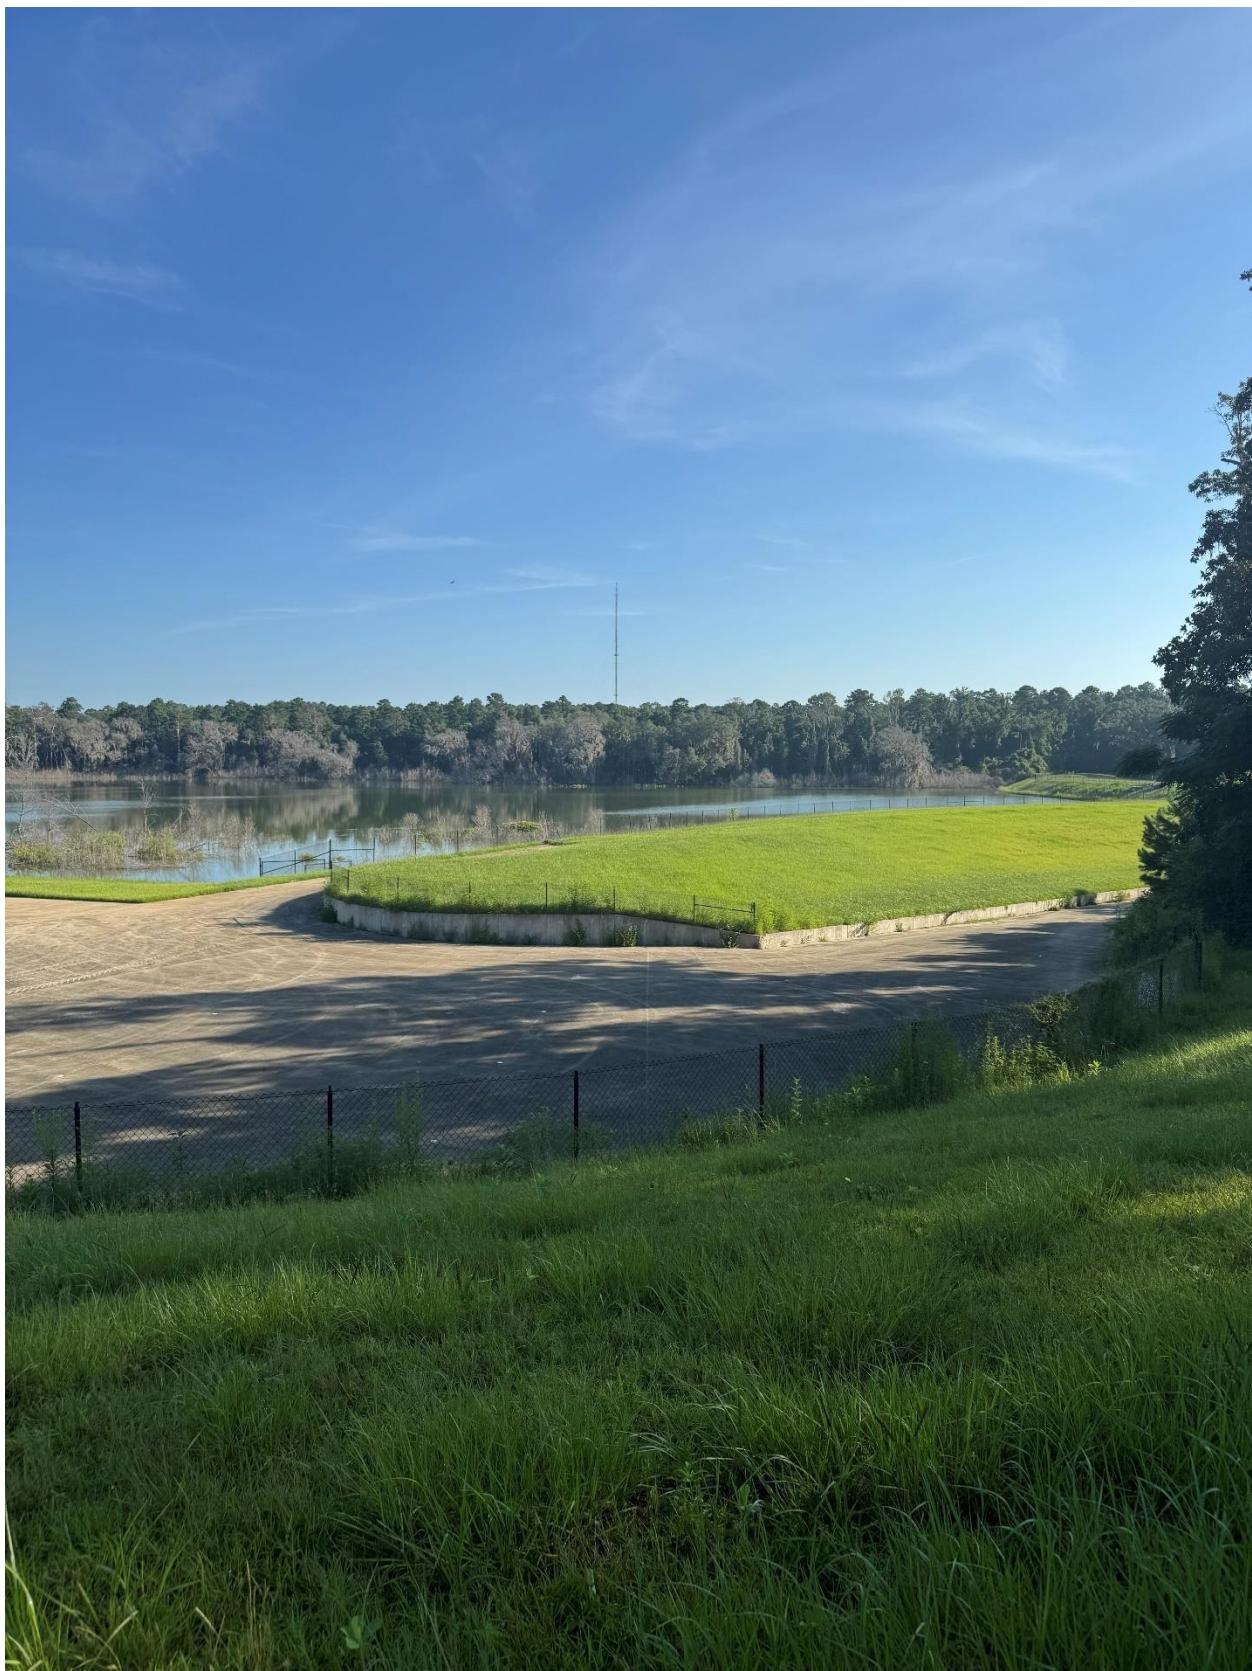
Photograph 3: Dove Dam Overflow Spillway, Looking from the Slope of the Dam

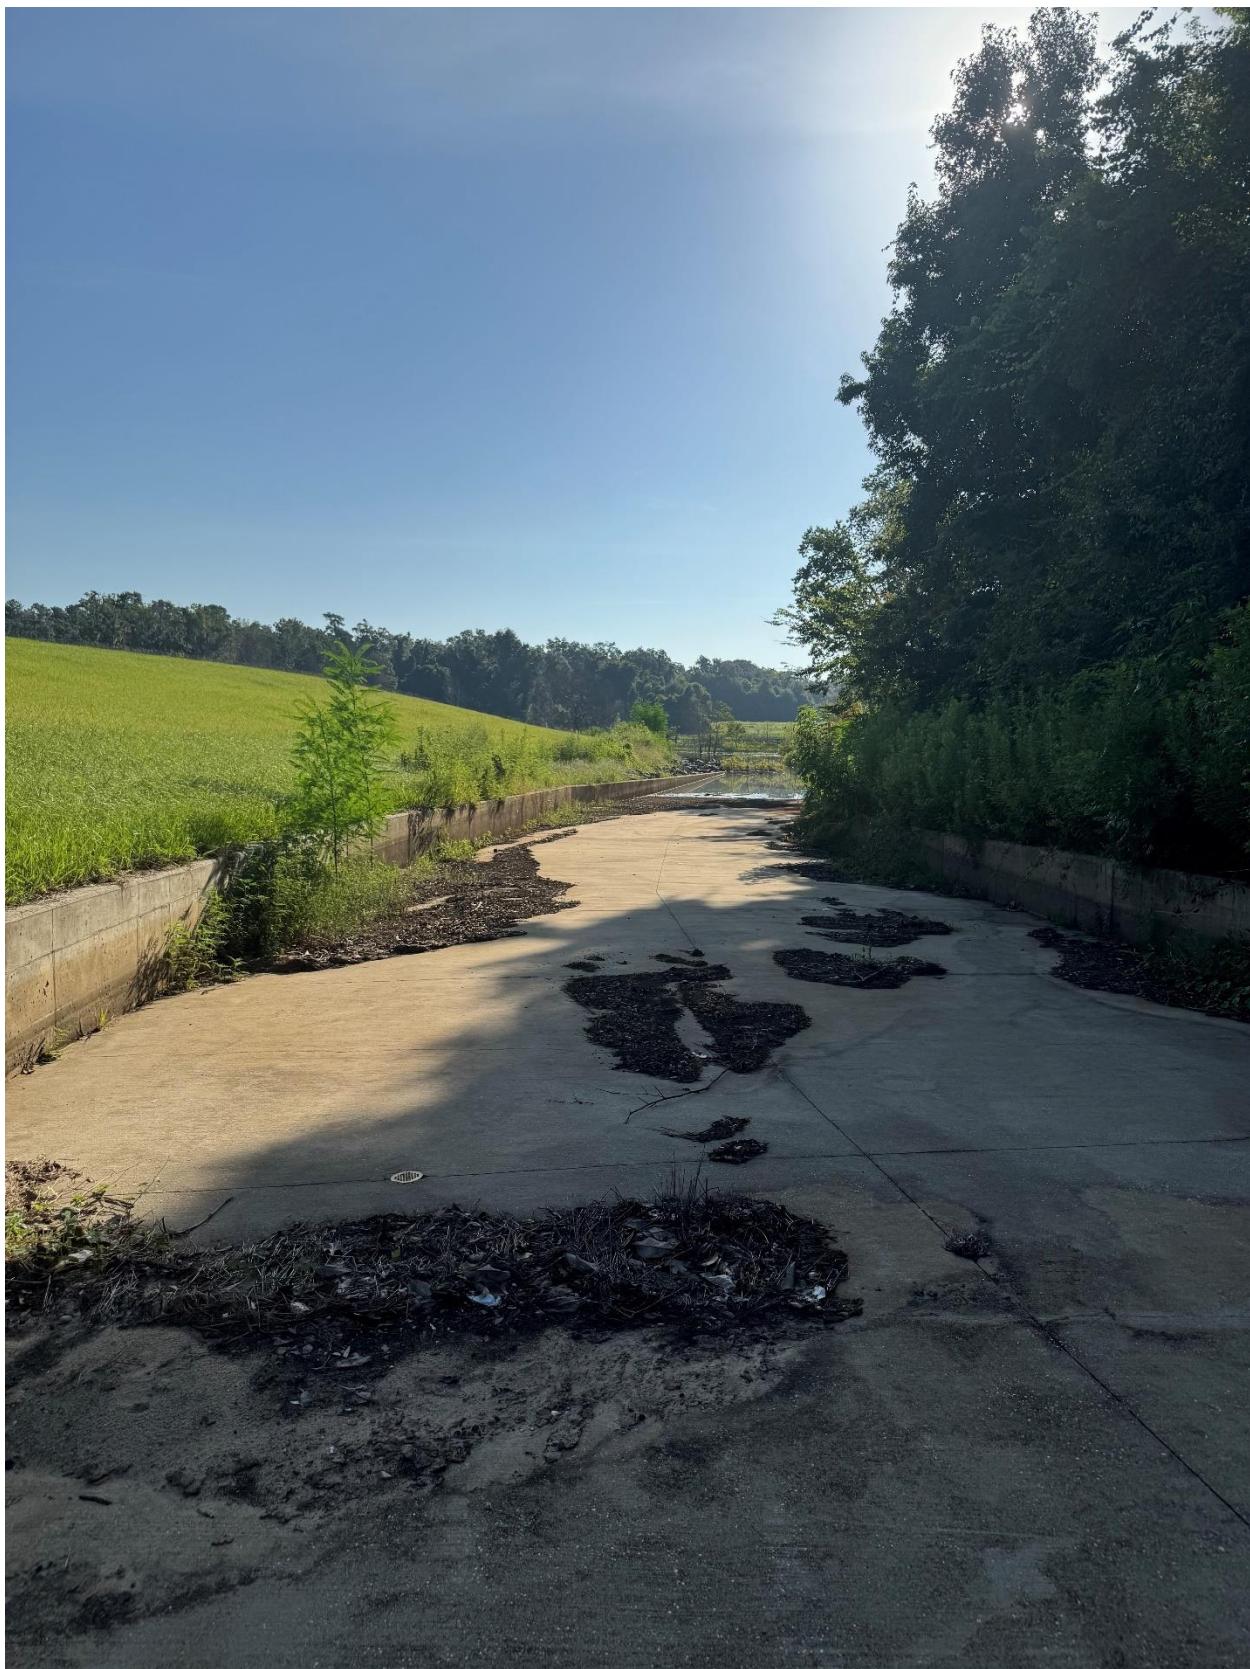
Photograph 4: Dove Dam Overflow Spillway, Looking Down the Spillway Ramp

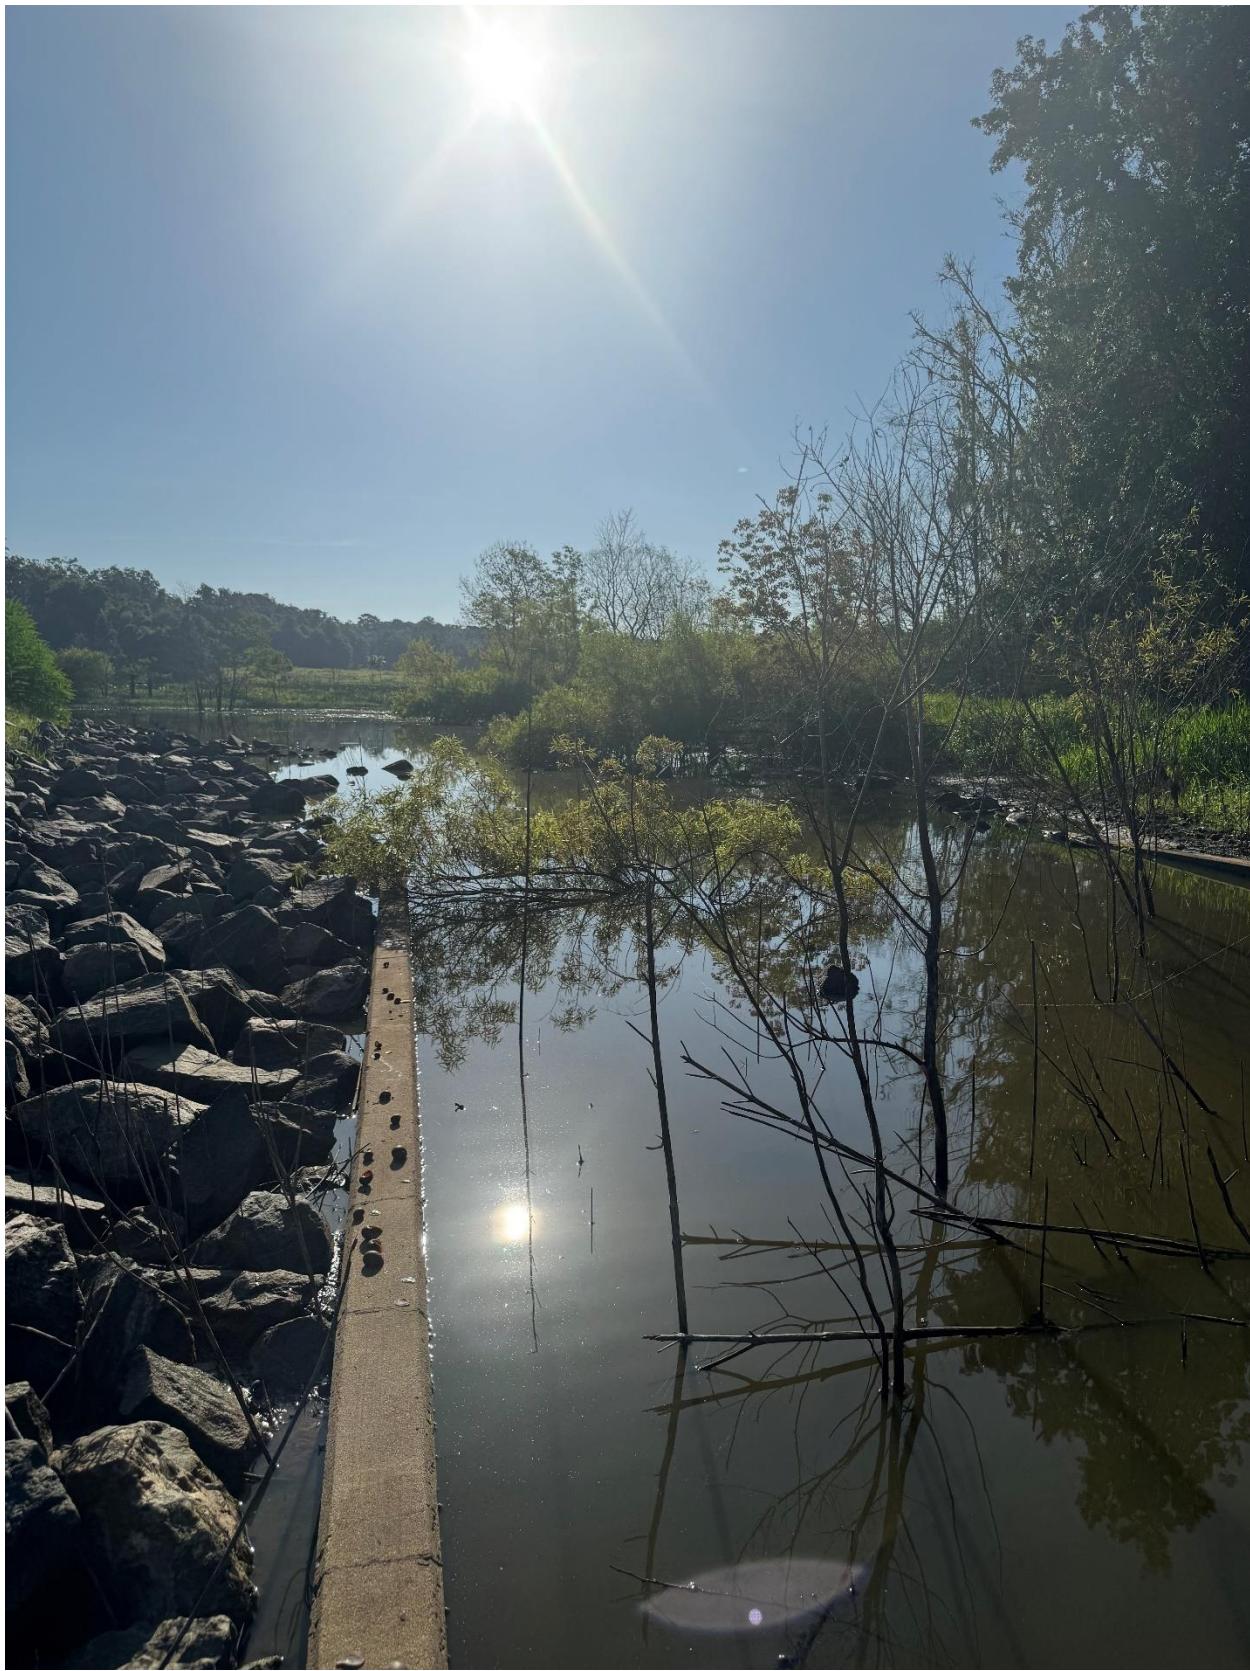
Photograph 6: Bottom of Dam Spillway

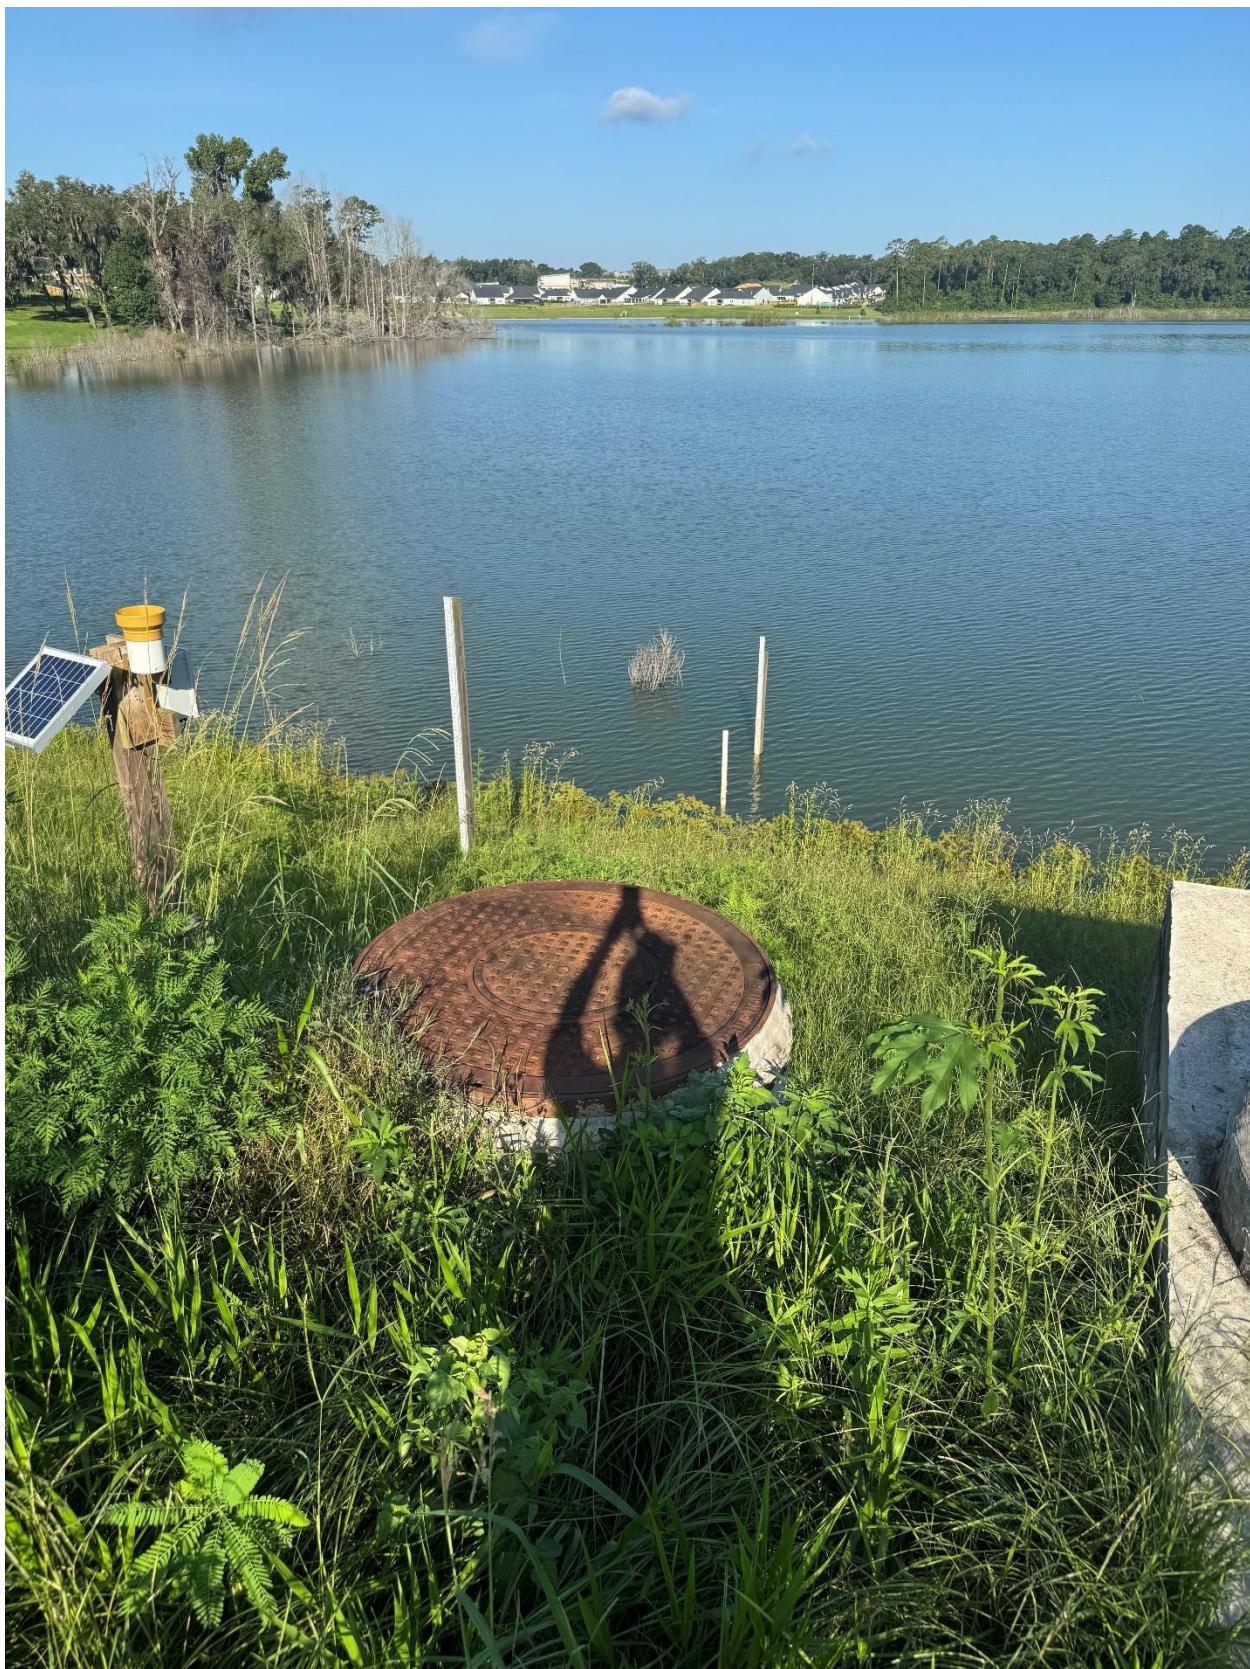
Photograph 7: Dove Pond Staff Gage Upstream of Dam
